conservatory which was attached to the Hall. There are no further access points into the walled enclosure, and no evidence of any having previously existed.

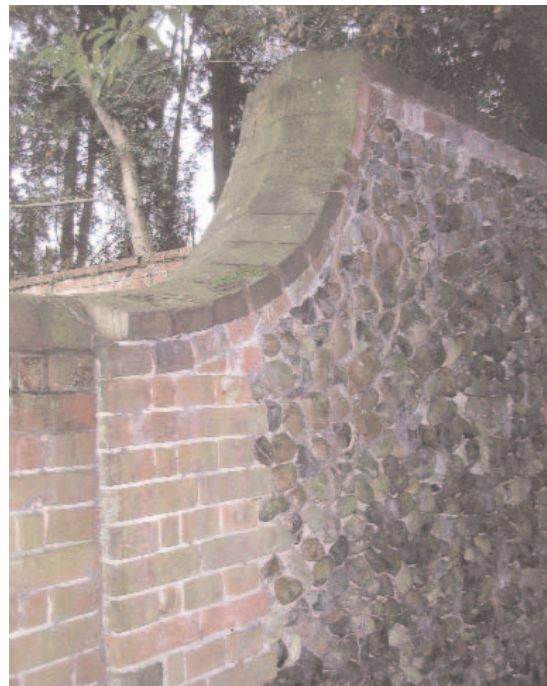
LEFT: The remains of lime plaster at the intersection of the east and south wall correspond to a structure shown as early as 1885. BELOW: The outside of the south wall, at its eastern end, showing the drop in height and brickwork butting-up.

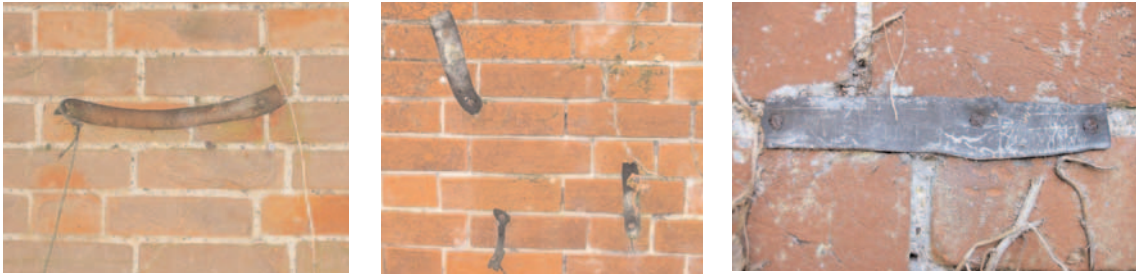
*LEFT & CENTRE: Leather straps found on the inside of the north wall and outside of the south wall.
RIGHT: Illegible lead label on north wall.*

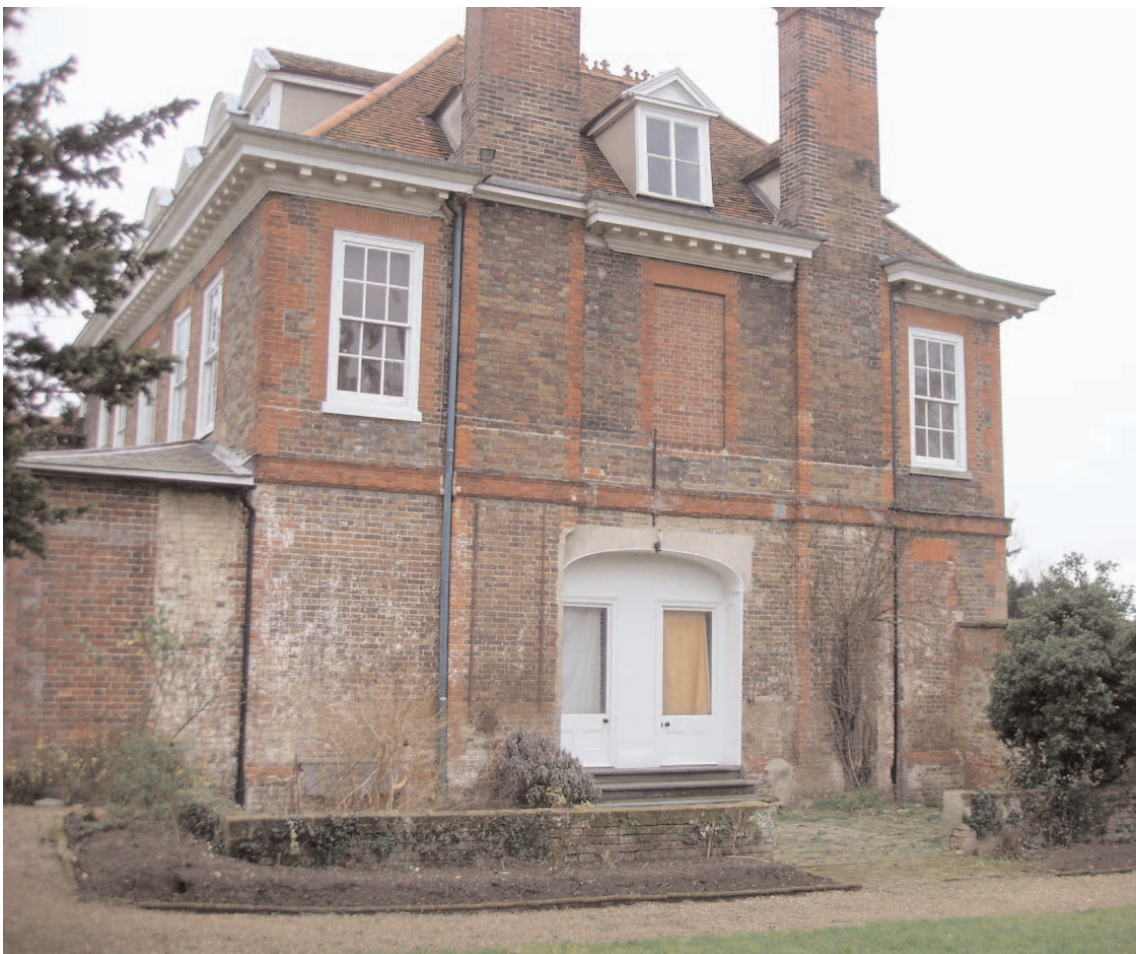
BELOW: The east elevation of the Hall showing the remains of the conservatory base.

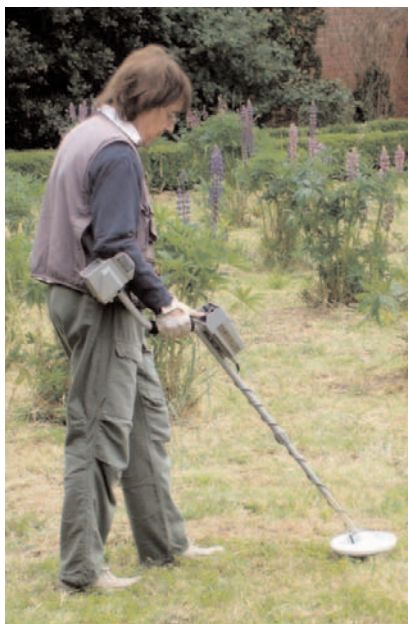
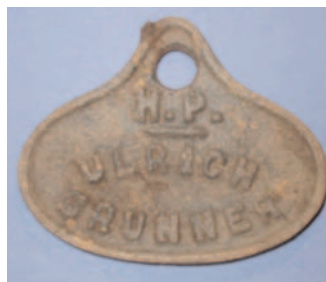
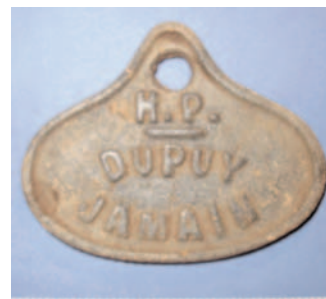
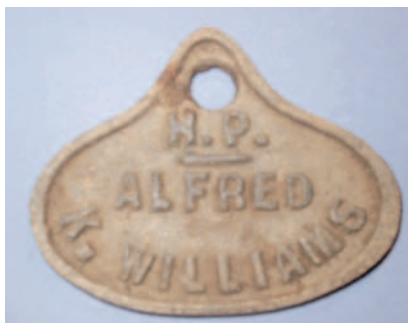
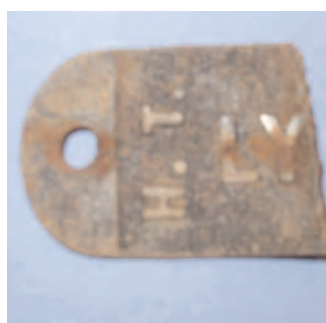
TOP RIGHT: Plan of walled garden showing position of rose labels found by Bill Wyman. Courtesy of Suffolk County Council. BELOW: Bill Wyman in action and some of the labels he found.

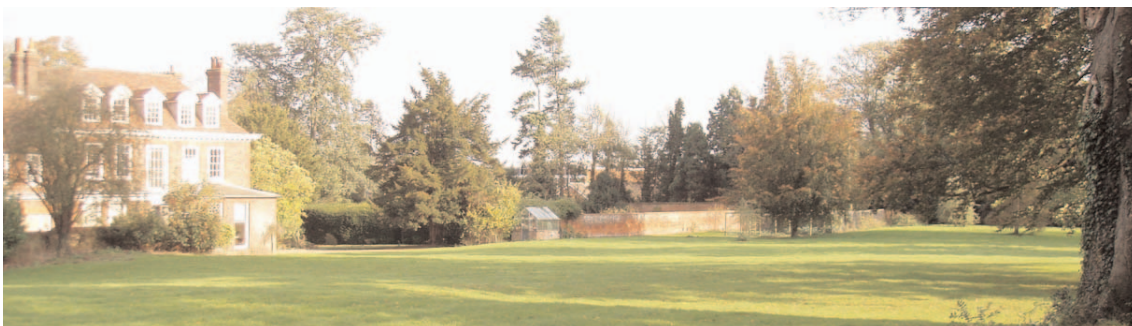
The walled garden seen from across the former formal south garden.
